## **STATUS REPORT SEPTEMBER 2016**

#### **Protecting our Rivers**

## **THE VIVIRY PROJECT**

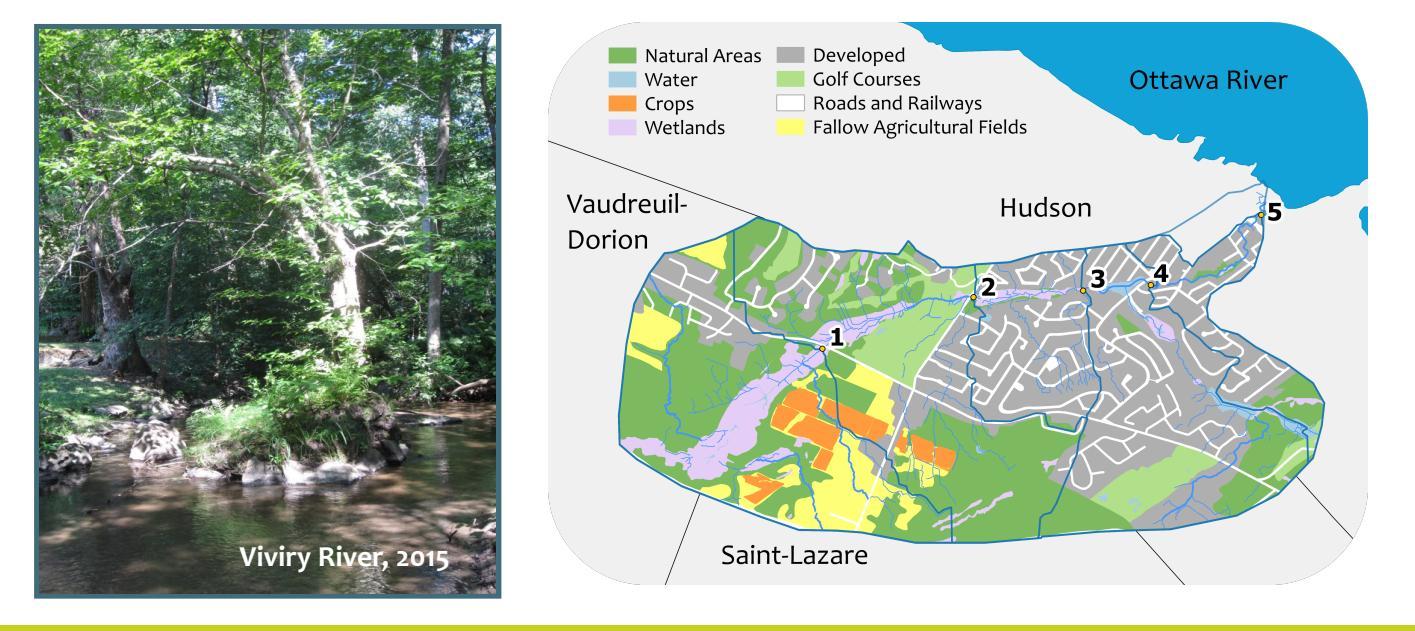
The Viviry basin is relatively small when compared with other watersheds of the RCM (10.3 km<sup>2</sup>) and the length of the main river channel is only 5 km. Over this short distance, however, the surrounding landscape changes substantially, 37.8% of the area being quite natural and 32.3% very developed. Agricultural fields, golf courses and road networks are also prevalent in the surrounding watershed, each acting as potential sources of pollution. We chose **five sampling stations** along the length of the river (see map below) to evaluate how changes in the surrounding landscape influence water quality.

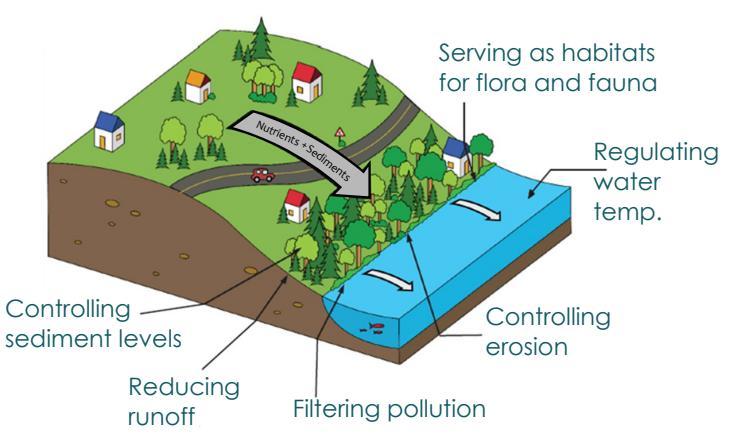
Ecological Roles of Riparian Buffers

At times underestimated, plants (trees, shrubs and herbs) protect rivers from pollutants sourced from the surrounding landscape. Vegetation that grows along the banks of rivers absorbs chemicals that can diminish stream health and helps to prevent erosion (see figure, "Ecological Roles of Riparian Buffers"). It is then essential to evaluate the capacity of riparian buffers to fulfill their ecological functions.

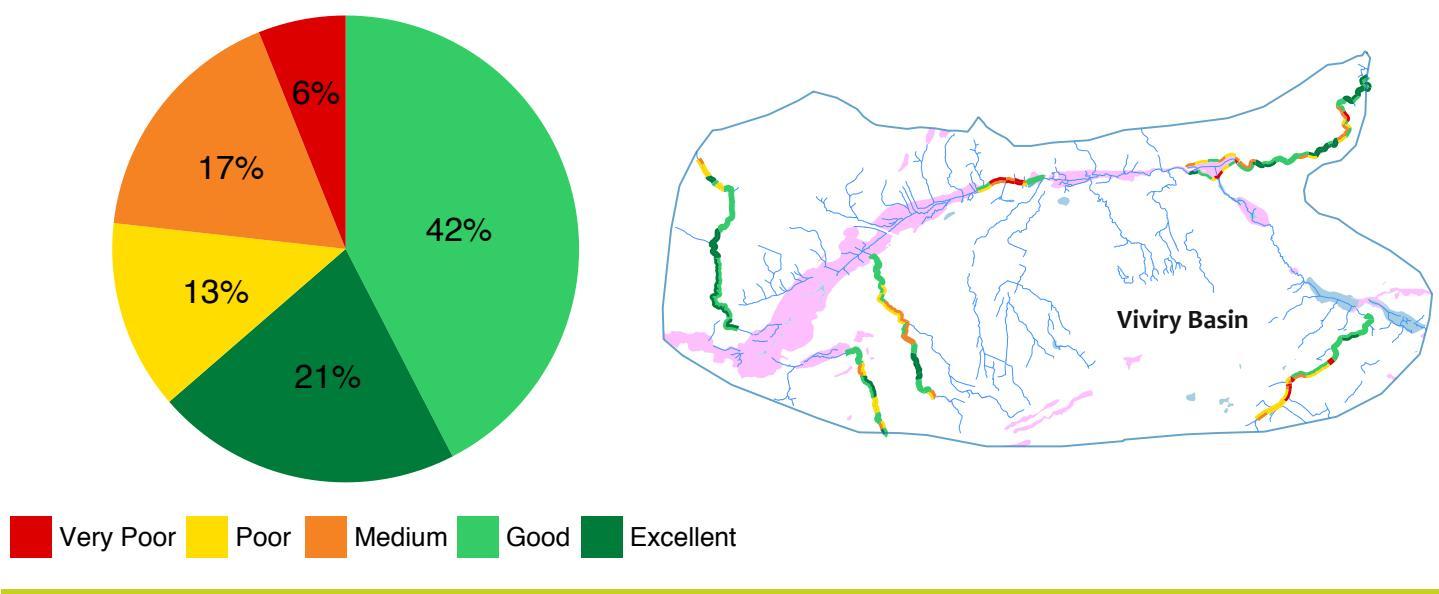
We used the Index of Riparian Buffer Quality (IRBQ) to class the shores of the Viviry into five categories ranging from "very poor" to "excellent". The method was developed by the *Ministère de Développement Durable et de la Lutte contre les Changements Climatiques* (MDDELCC) and is based on the coverage of nine landscape categories (forests, shrubs, herbs, logged areas, fallow land and grassland, crops, bare soil, exposed bedrock and infrastructure) found along the length of the river, each one weighted according to its influence on water quality.

Results show that most of the riparian buffers along the Viviry and its tributaries are good (42%) or excellent (21%). However, improvement is needed in some areas (see map below).

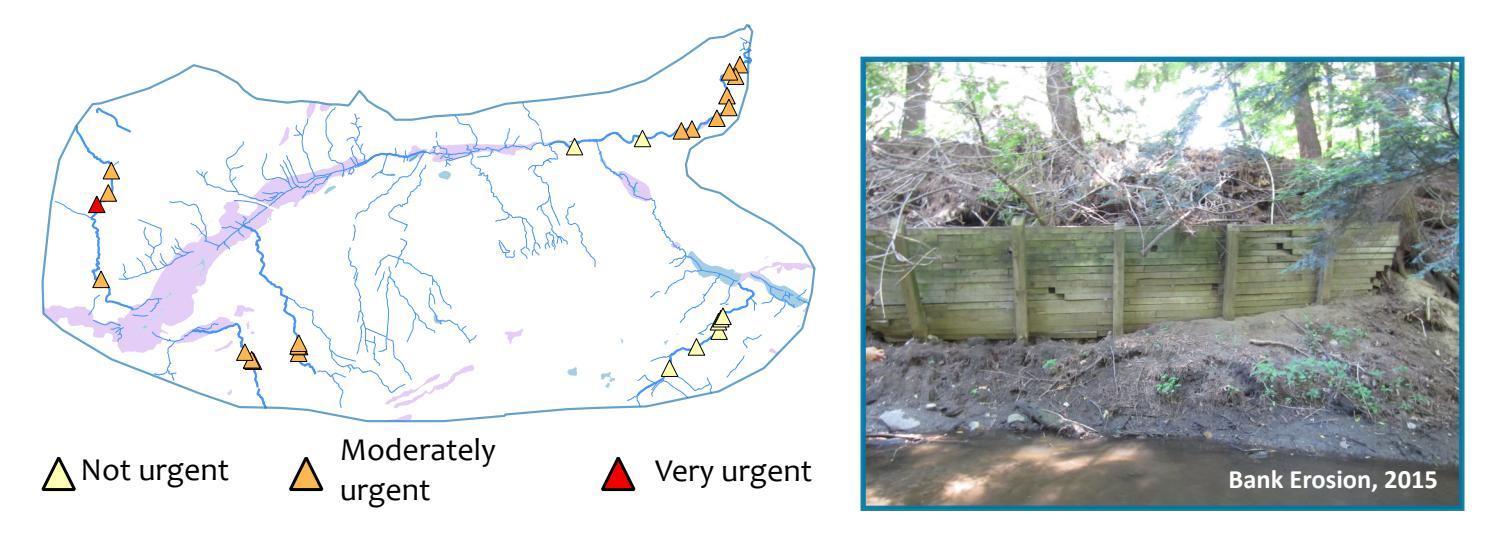
**Bank erosion** is a natural phenomenon that is constantly taking place. Nevertheless, this process can be greatly accelerated by certain anthropogenic activities such as **deforestation** and **development**. We identified critical points of erosion along the entire length of the Viviry, evaluating the intensity and type of erosion and whether intervention was urgently needed (see map).

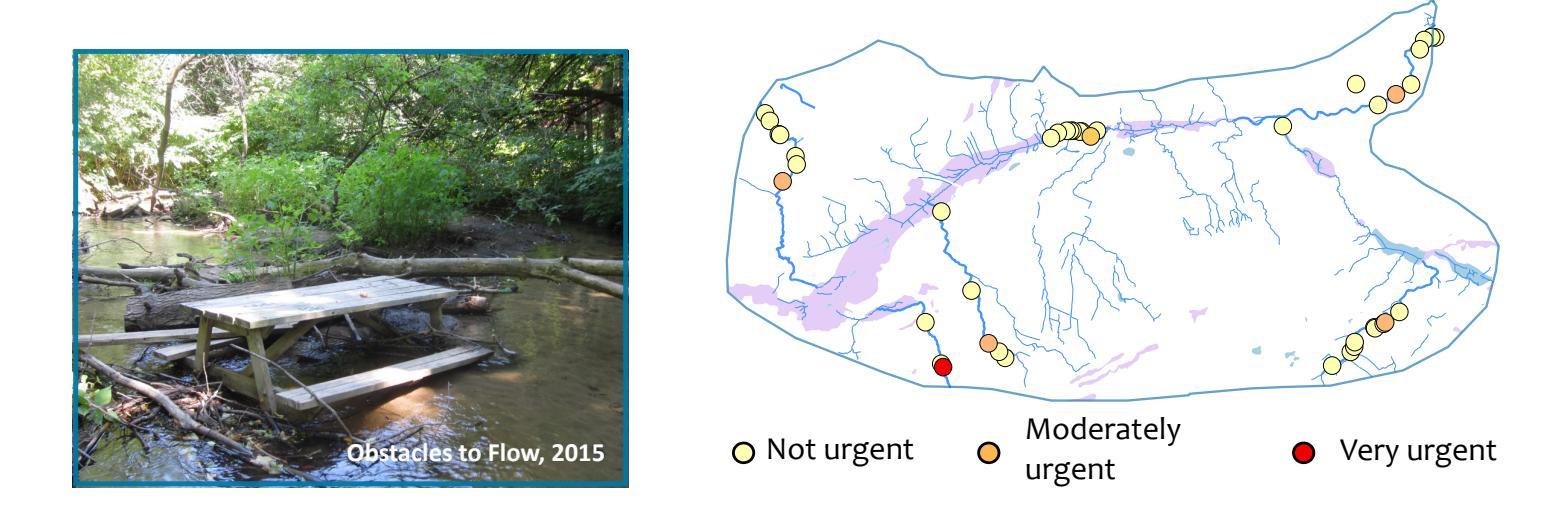
**Obstructions to water flow** can be quite problematic as well. In fact, obstacles can **block water flow**, **erode riverbanks** and even cause **flooding**! We paid special attention to obstacles along the river, which primarily consisted of fallen trees, refuse, drains, dams and obstructed culverts.

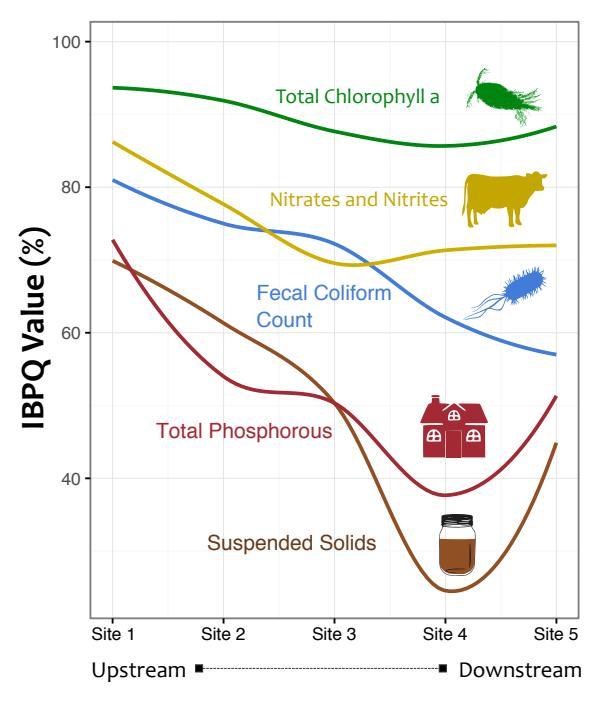
In the graph below, coloured lines represent the different chemical variables. Clearly, **IBPQ is much higher at the river's headwaters** where the surrounding landscape is more natural than further downstream where it's especially urban.

Phosphorous and suspended solids sourced from urban runoff build up in the water column at Station 4 because of the dam at Pine Lake. These pollutants are then filtered from the water to some degree by the wetland protected by the town of Hudson at Station 5 - an example of successful conservation in action!

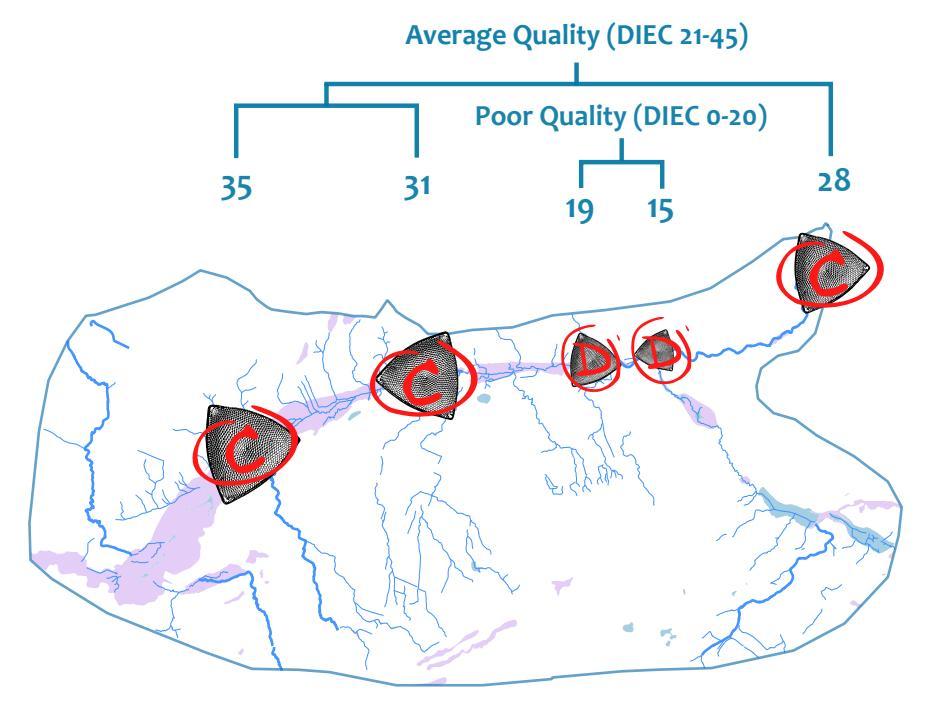
**DIEC** is based on the community composition of **diatoms**, which are brownish microscopic algae that carpet river bottoms. Diatoms are used as indicators for the health of plants and animals in the river since they're sensitive to the concentration of nutrients (e.g. nitrogen, phosphorous) in the water column and to the presence of organic matter. While pollutants negatively affect some species, others thrive off of them! This index measures water quality by comparing the diatoms found in the river with those that would be expected under polluted conditions. Water quality is graded from A (good water quality) to F (poor).

On the whole, DIEC results for the Viviry tend to be negative. Samples from the different stations indicate relatively average to poor conditions for diatoms and thus other plants and animals as well. Stations 3 and 4 obtained the lowest scores (D) likely due to the urban areas adjacent to these sites. Stations 1, 2 and 5 are all located in municipally protected wetlands that filter nutrients from the river.

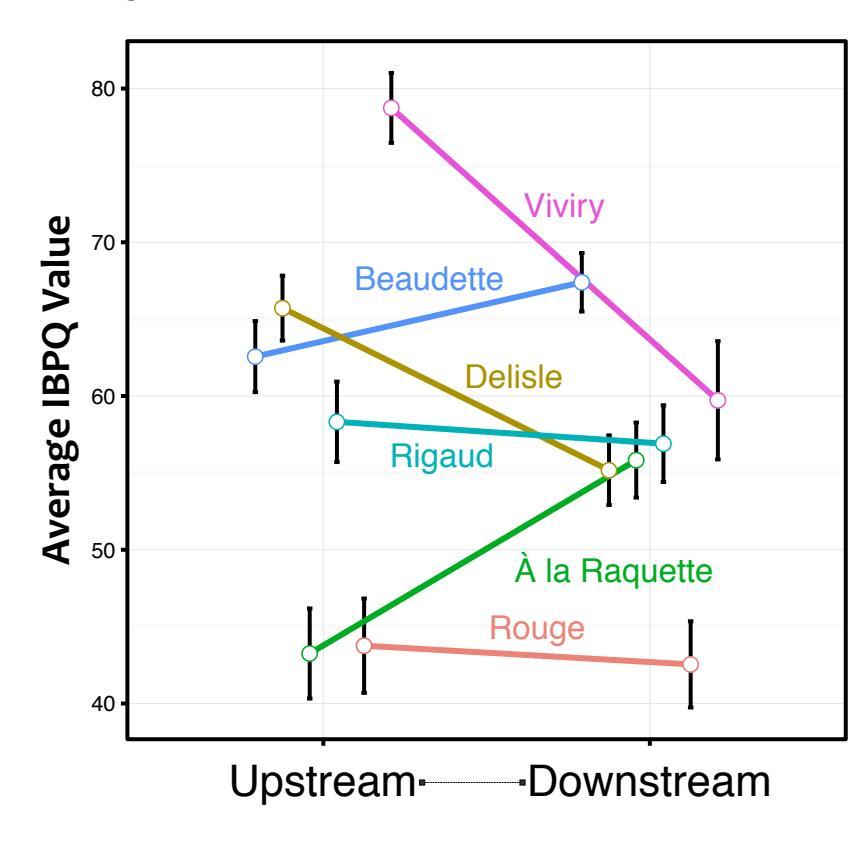
downstream. We compared the different rivers using a number of chemical measures including: fecal coliform count, total phosphorous, nitrates-nitrites, suspended solids, pH and turbidity. The graph below shows the average IBPQ values for each river across all measures at their respective upstream and downstream sites. Values range from 0 to 100 with higher values representing better quality water.

As you can see, the **Viviry has the highest water quality across all parameters at its upstream site**. Further downstream, however, water quality is as poor as most other rivers because of fecal bacteria and phosphorous polluting the river from nearby residential areas. Unlike the Viviry, runoff from agricultural areas is the greatest source of pollution for the other rivers.

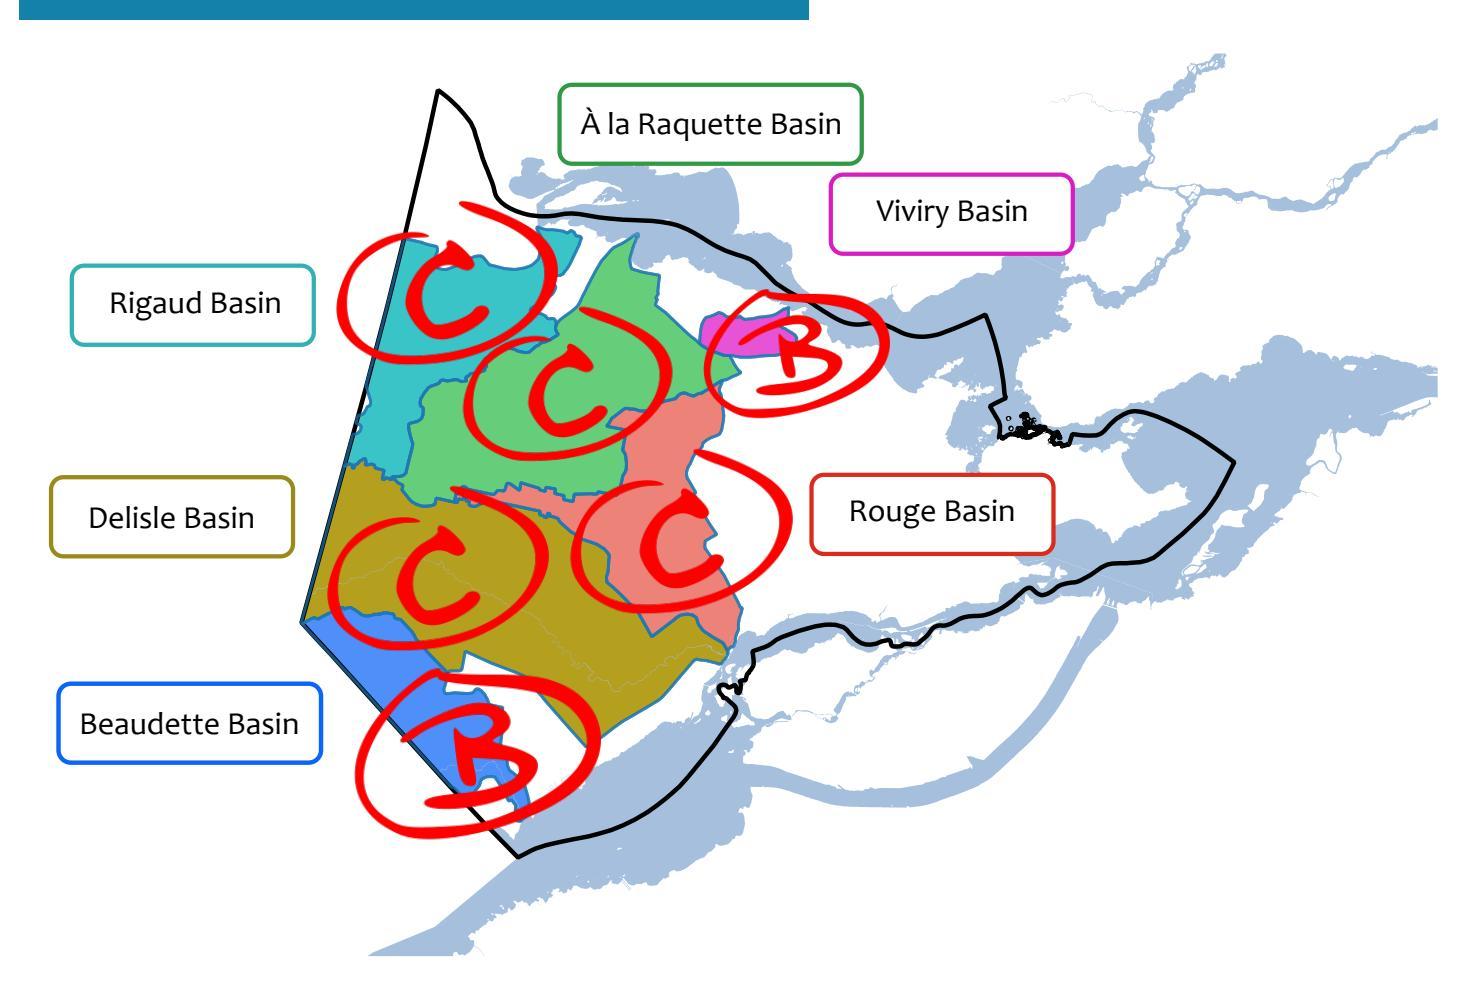
On the above map, IBPQ scores are given to the watershed of the À la Raquette, Beaudette, Delisle, Rigaud, Rouge and Viviry rivers. The Viviry and Beaudette score well with a grade of B while the watersheds for the other rivers fare less well and get a grade of C. The issues encountered on the Viviry are largely related to high concentrations of **phosphorous**, **fecal coliform count and suspended solids** originating from urban areas. On the contrary, the other rivers in the Vaudreuil-Soulanges region have **high levels of phosphorous** from nearby **farmlands**.

The Rouge river has the worst results, be it at its upstream or downstream site. Upstream, the À la Raquette has results similar to those of the Rouge but its water quality increases downstream. For the Beaudette, Delisle and Rigaud rivers, there's little change in IBPQ at their upstream or downstream sites, having generally intermediate values.
